OPTIMIZATION OF AUTOMATED GRANITE PROCESSING PLANT

*** Sandeep Acharya,**
**** Dr. Ramachandra C G,**
**P.G Scholar*
*** Professor & Head*
Department of Mechanical Engineering
Srinivas Institute of Technology
Mangaluru, India

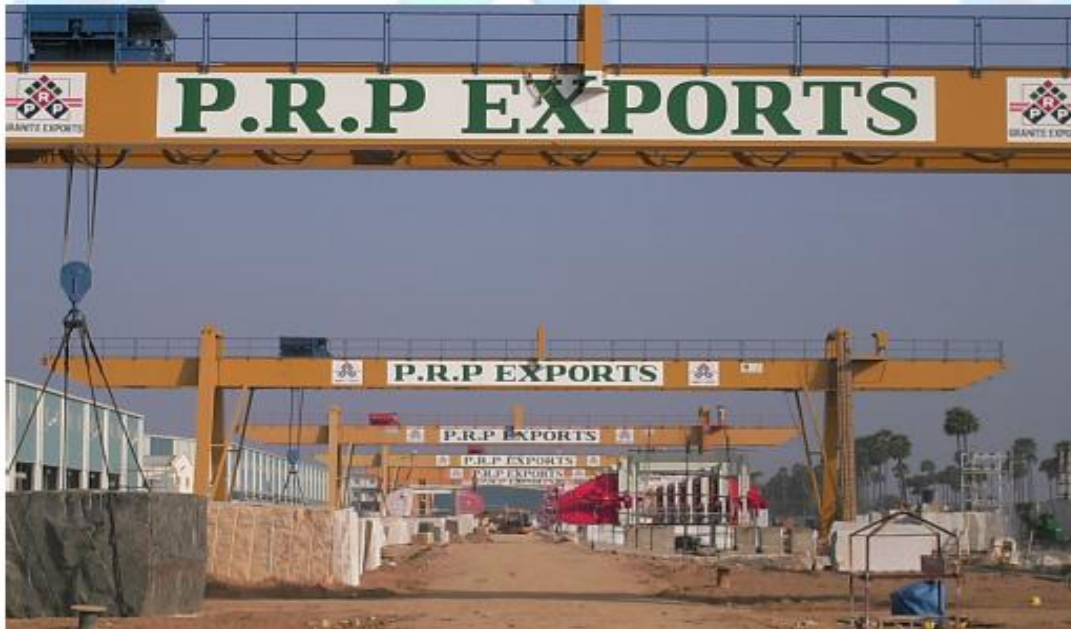
Figure 1. Gantry Crane.

The Rough Blocks that are received from Granite Quarries are unloaded from the trucks that transport in the Block Yard using a Gantry Crane [05]. The Blocks are inspected by qualified inspectors for defects. Blocks with major defects are stored separately or sent back to the quarry. Blocks that pass the inspection are then checked and a planned for a squaring operation using a Stationery Wire Saw machine. Normally, the Blocks are dressed on the Top surface and bottom surface using a wire saw. Sometimes if the Blocks are too wide or too uneven then the sides also are dressed using the same Stationery Wire Saw machine. The dressed Blocks from the Wire Saw machine are stored separately. These blocks are then loaded on to a Gang Saw Block Trolley using the Gantry Crane. The loading of the Blocks for sawing are dependent on the production program issued by the management.

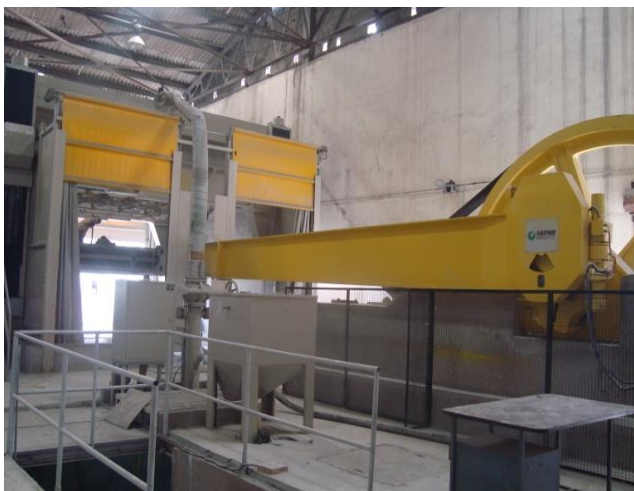
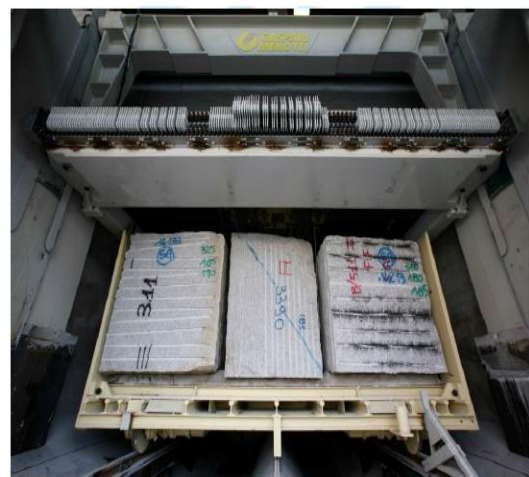
Figure 2. Gang Saw Machine.

The blocks that are loaded on to the Gang Saw are set by means of cement after providing ample/suitable packing below to make the Block stable and balanced. The Block Trolley is moved under the Gang Saw Frame by means of the Transfer Trolley winch and pulleys. The Blade Frame of the Gang saw is loaded with suitable number of Blades depending on the size of the Block. The Blades are tensioned by means of an Automatic Tensioning system

Once the Blade Frame is ready with Tensioned Blades and the Mixture Pit is ready with the Sawing Mixture, the gang saw is started and the cutting operation starts. The cutting is performed by the Steel Grit which acts like teeth to the Steel Blades. The steel grit disintegrates due to the cutting action. There is Steel Grit Reclamation Unit which separates the good/useable steel grit from the bad un-useable steel grit, which is taken out of the system.

Depending on the hardness of the material, quality of the blades [06] and steel grit the gang saw is able to complete the sawing in between 45 – 90 hours of cutting in each

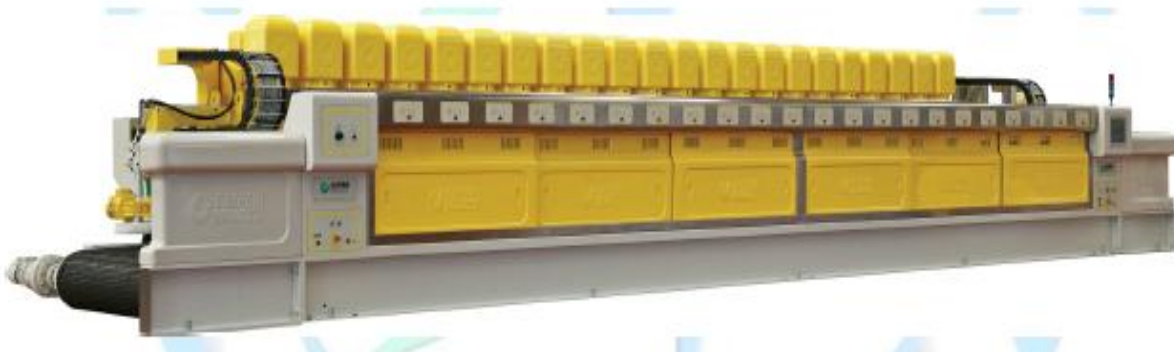
Figure 3. Grinding and Polishing Machine.

The Automatic Grinding and Polishing machine first Grinds the Slabs automatically and prepares the surface for resin Treatment in the Resin Line.

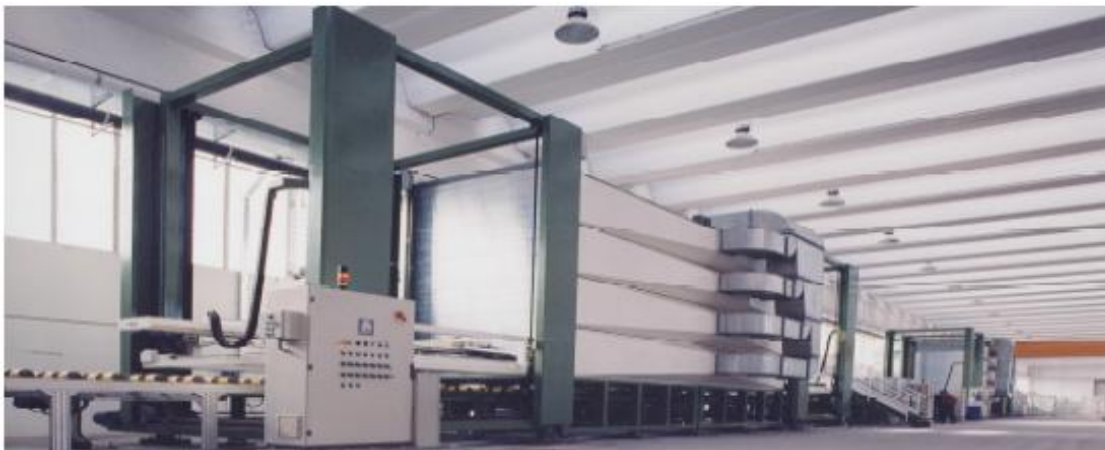
Figure 4. Resin Line.

The Honed slabs are first dried in the Drying section of the Resin Line for at least 60 minutes at a temperature of 45 – 50 o Centigrade to remove all humidity. These dried slabs are then applied with a thin coating of Epoxy Resin [07]. The slabs thus treated are sent to the drying chamber / catalysis chamber to harden the Epoxy Resin. The catalyzed slabs are unloaded from the resin Line and stored. Such slabs stored for 24 hours will be ready for Polishing. The resined and cured slabs are then automatically loaded on the Polishing Machine with suitable series of abrasives and polished. The Slabs which come out of the Polishing

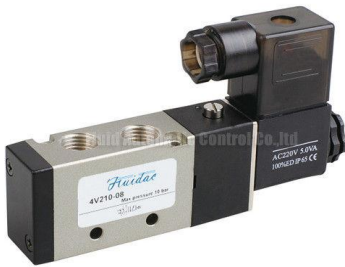
Figure 7: single acting pneumatic valve

As in current condition of polishing machine is works with a single acting pneumatic valves, because of this the pre approaching of the polishing heads is not working, and also there is no control over the polishing head. So for this single acting pneumatic valve is replaced by double acting pneumatic valve in order to get the pre approaching and also the controlled movement of the polishing head.

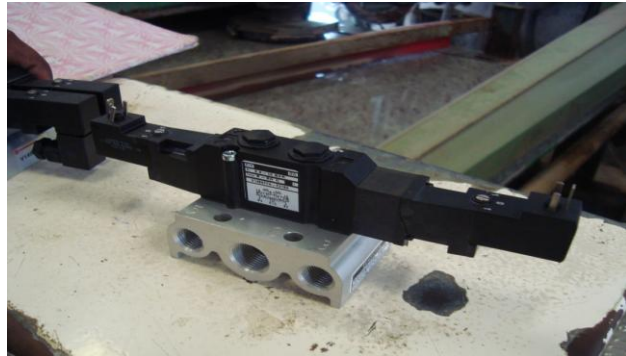
Figure 8: Double Acting Pneumatic Valve

This double acting pneumatic valve is having two inlets where controlled pressured air is supplied in one inlet, i.e. P2 and the direct pressure air is supplied in other, i.e. P1. Hear the
